NEW YORK NAVAL SHIPYARD
NAVAL BASE, BROOKLYN 1, NEW YORK

975:CL:hW
Lab. Project 5319-39
Final Report

Subj: Atmospheric Contamination from Selenium Rectifiers SF-013-12-09

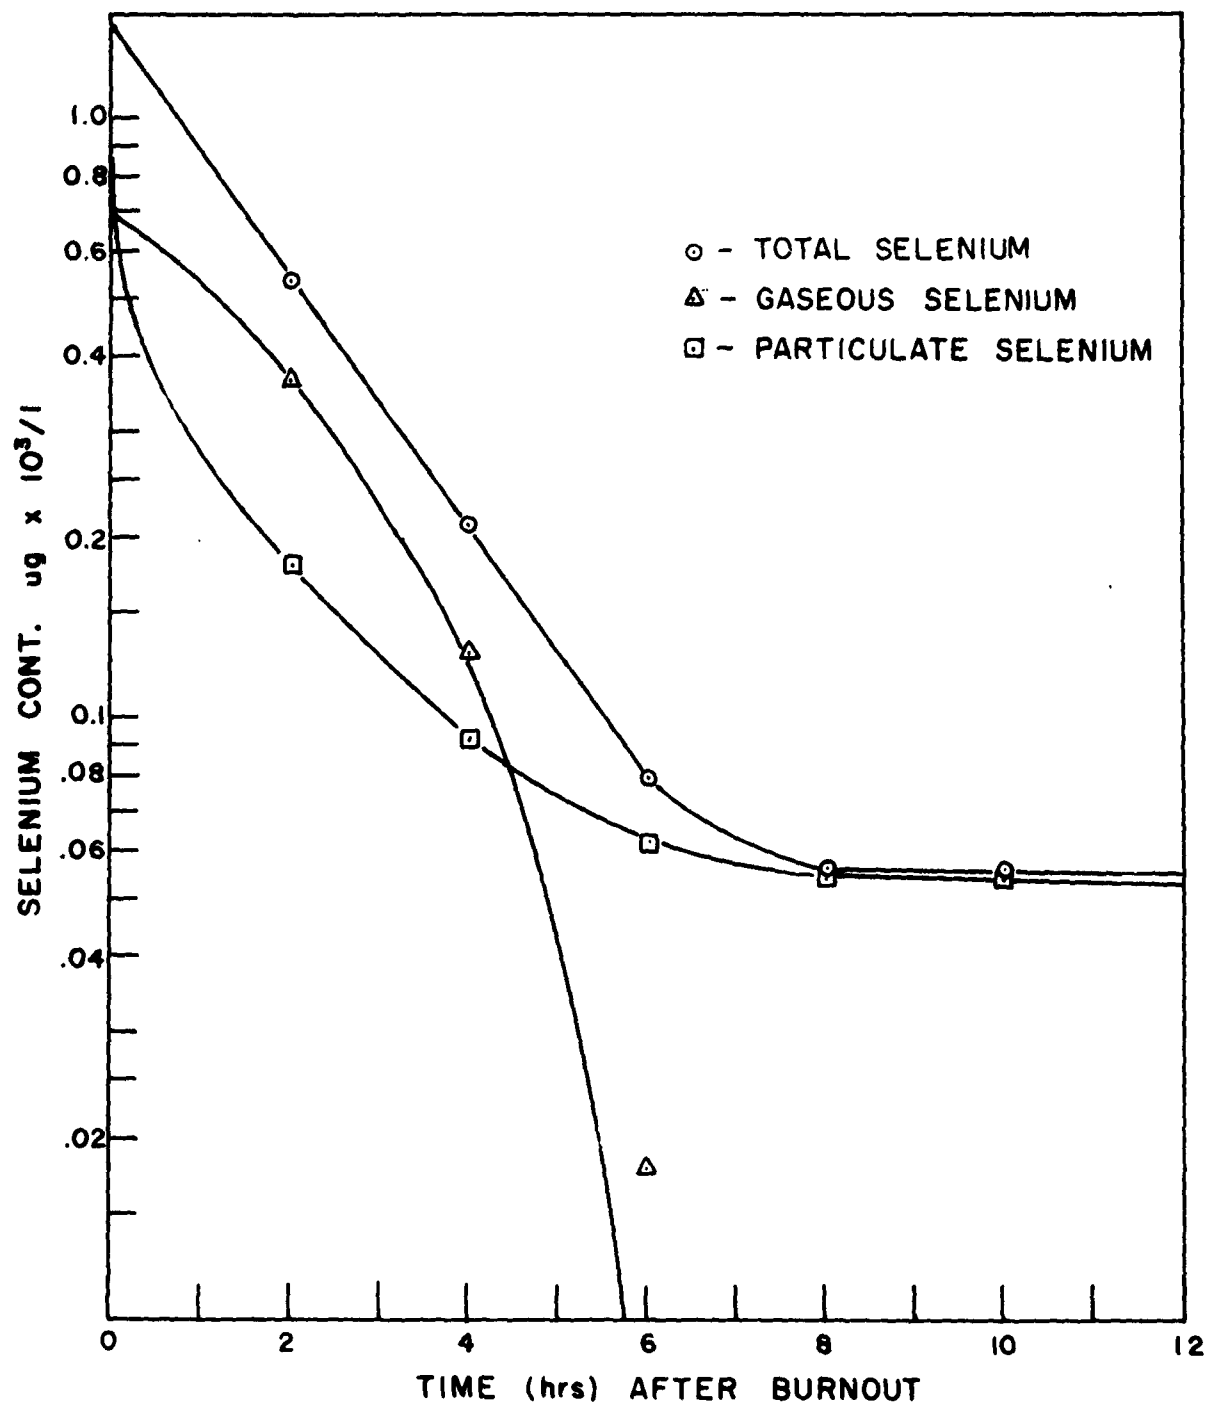
ENCLOSURE 2. PLOTS OF SELENIUM CONTAMINATION IN ATMOSPHERE VS. TIME AFTER RECTIFIER BURNOUT

4. The concentrations of selenium gaseous and particulate contamination produced on burnout of the 6"x4" twelve plate rectifier at the severe electrical loading level of 960 volts A.C. and 30 amperes D.C. are shown in enclosure (1). On burnout, the combined particulate and vapor selenium concentrations, averaged for the first two hours of monitoring, was 0.54×10^{-3} $\mu\text{g/liter}$. As illustrated in enclosure (2) the gaseous selenium curve shows a rapid exponential drop to background level in approximately four hours. The particulate selenium content descends to a constant level after 8 hours of atmospheric monitoring. The residual value of 0.054×10^{-3} $\mu\text{g/liter}$ of selenium is higher than background and may be due to circulation of selenium dust that deposited on various surfaces in the room on burnout of the rectifier. Analysis of adhesive paper, $6\frac{1}{2} \times 6\frac{1}{2}$ inches which represents particulate fallout placed 2 in. and 24 in. from the rectifier gave values of 0.90×10^{-3} and 0.35×10^{-3} $\mu\text{g/sq. in.}$ respectively for a 20 hour period. A photo of the rectifier after burnout is shown in enclosure (3).
